Recent FE-B Module Experience at LBL

K. Einsweiler, LBNL

Status and results from first two FE-B modules

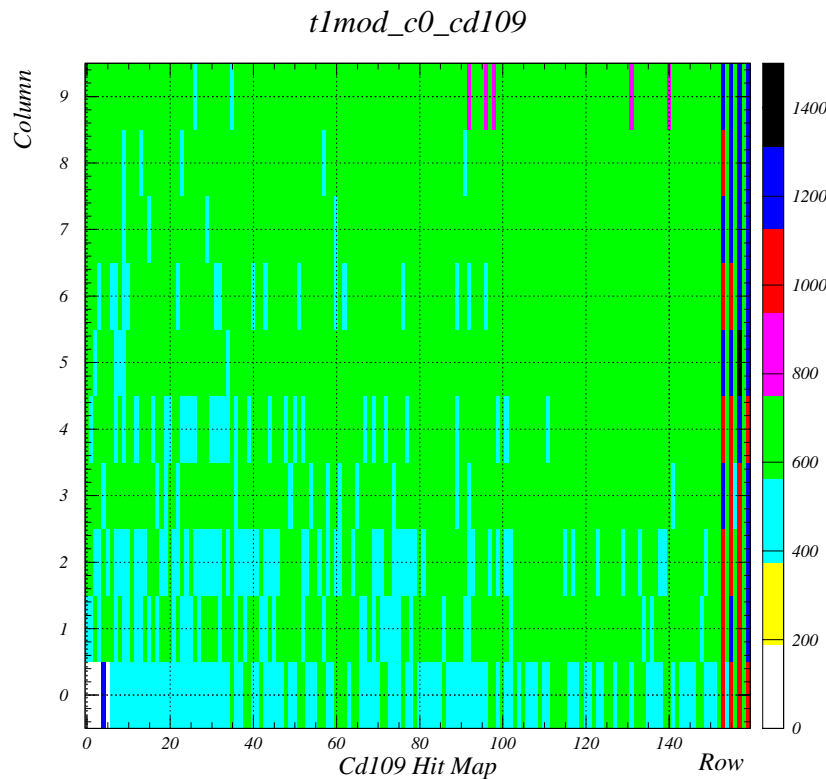
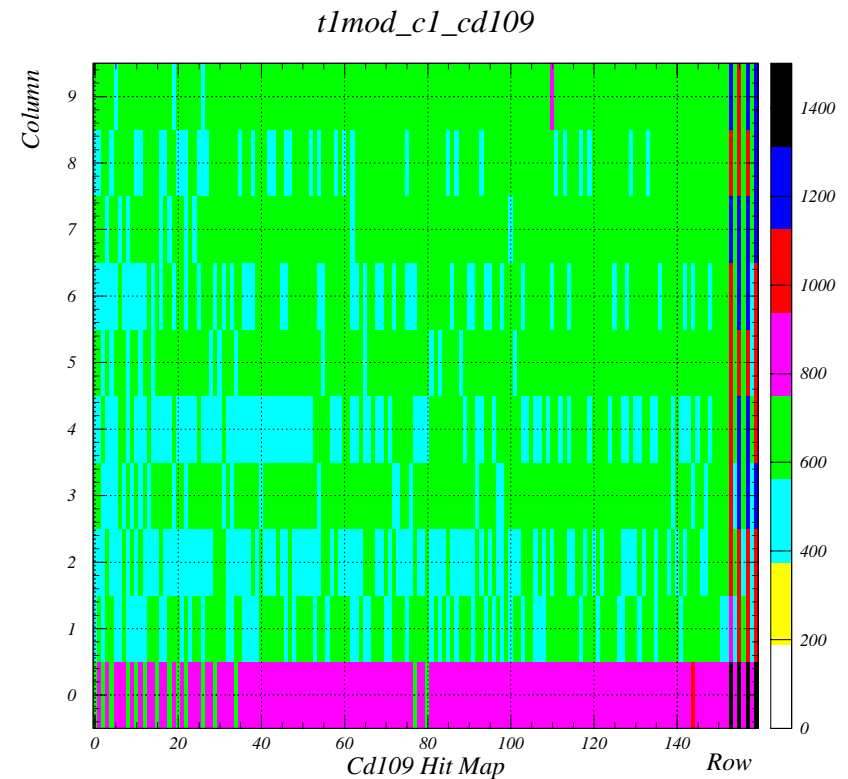
- Source maps were made for each chip before doing TDAC tuning of thresholds (threshold about 4.5 Ke):

- Note Chip 0 and 8 in Tile have Column 0 400 μ long, all others have 600 μ .

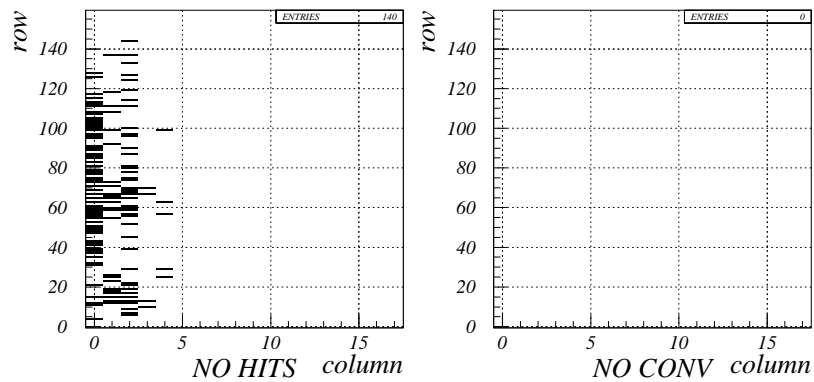
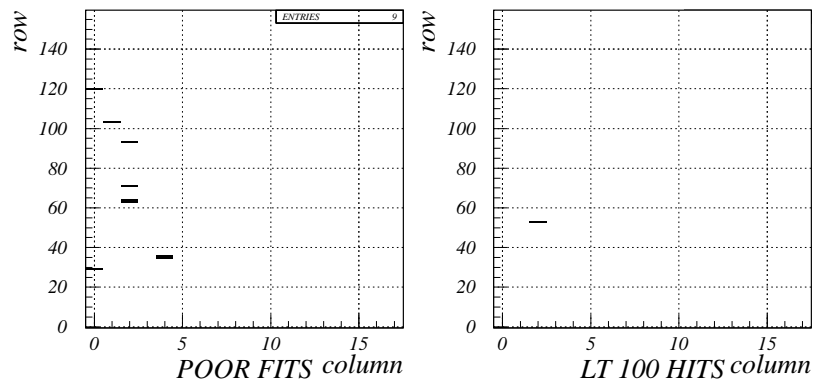
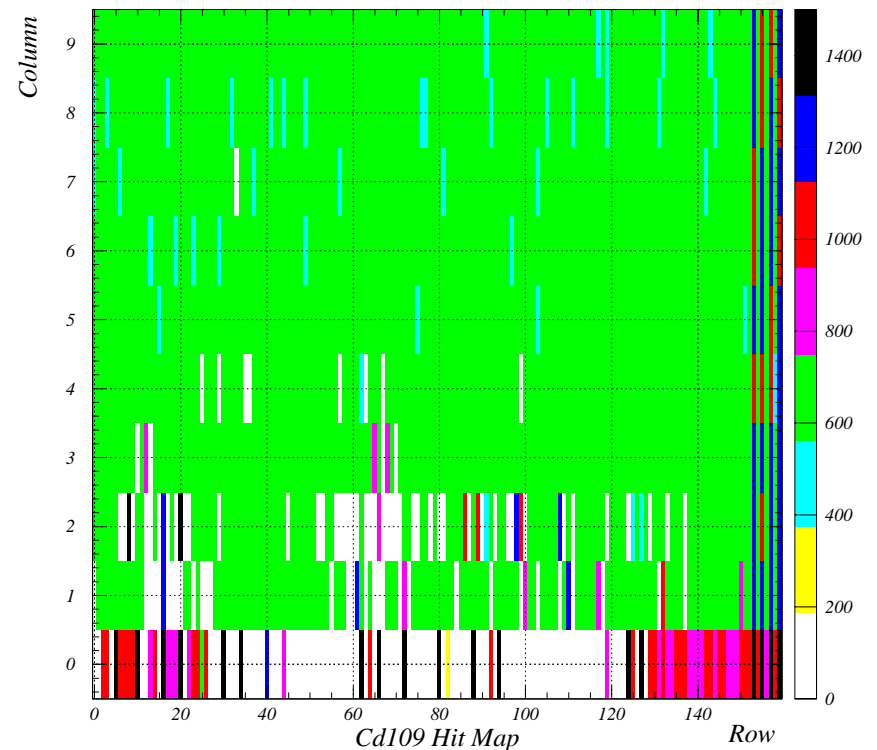
Bad Chip 14 in Tile 1:

- The Tile1 module has only a few dead channels, with the exception of one chip (Chip 14) which has about 140 dead channels, mainly in the first two columns. Here, dead means that when doing a threshold scan, these channels produce essentially no hits.

- Both charge injection and source run show similar behavior:

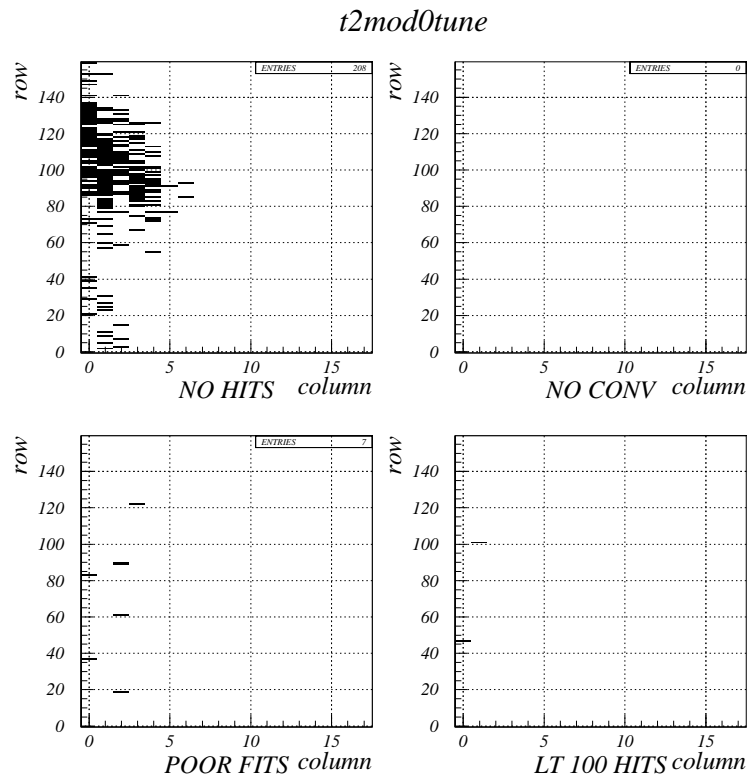
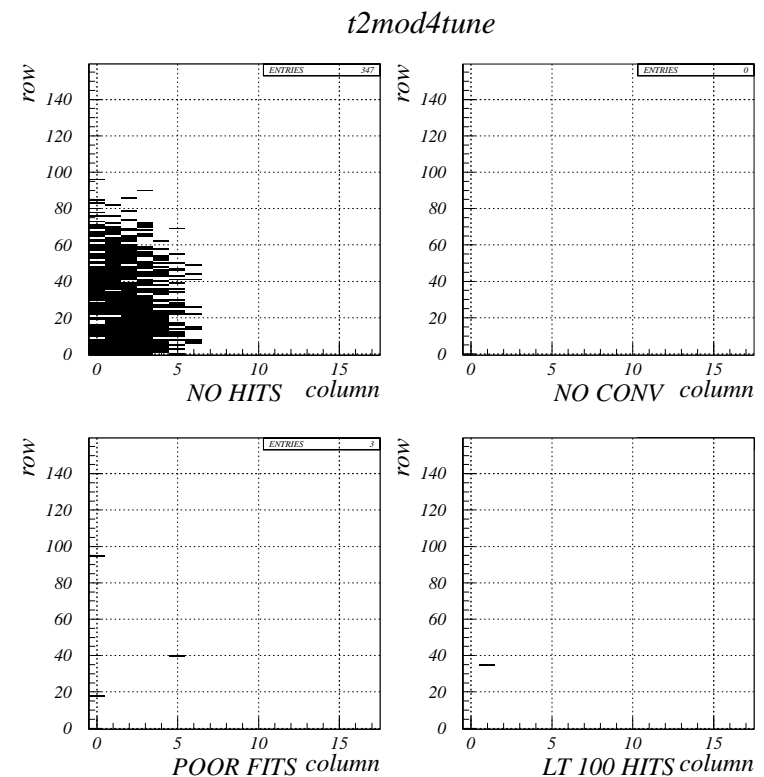
Examples of two bad chips from charge injection:

- The Tile2 module has many dead channels, mainly in the chips on one side (a total of about 800 bad channels are found, most of them in Chips 0 and 4).

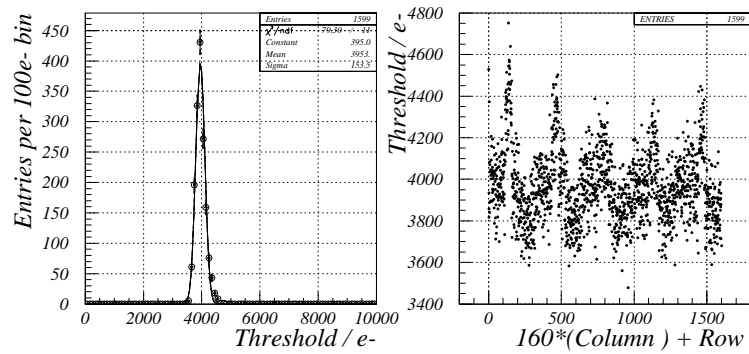
t1mod_c0_tune

- For most studies, the preamplifier feedback current (FPDAC or DAC1 in FE-B) was set to 5, corresponding to about 1.5 μ s return to baseline for 20Ke charge. At this operating point, we typically observe about 110e of noise on both ST1 and ST2 detectors (single chip devices on the single chip support card).
- For the modules, noise values in the range of 150e up to even 400e or 500e have been observed. These measured noise values change significantly from one threshold scan to the next in an apparently random way. Sometimes, there is even a corresponding “column-dependent” threshold shift observed.

Two examples of chips which were noisy:

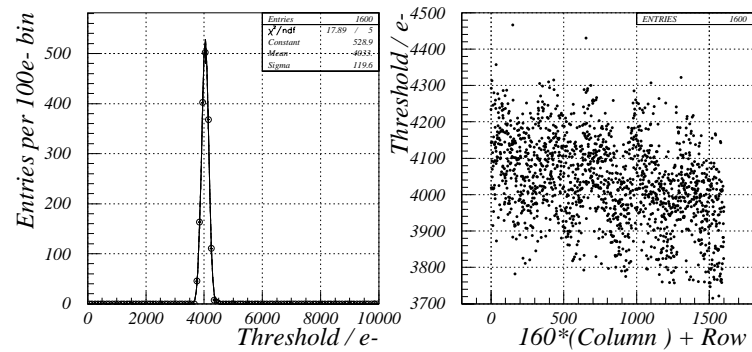
t1mod_c3_tune1

Examples from the same chip a few minutes apart:

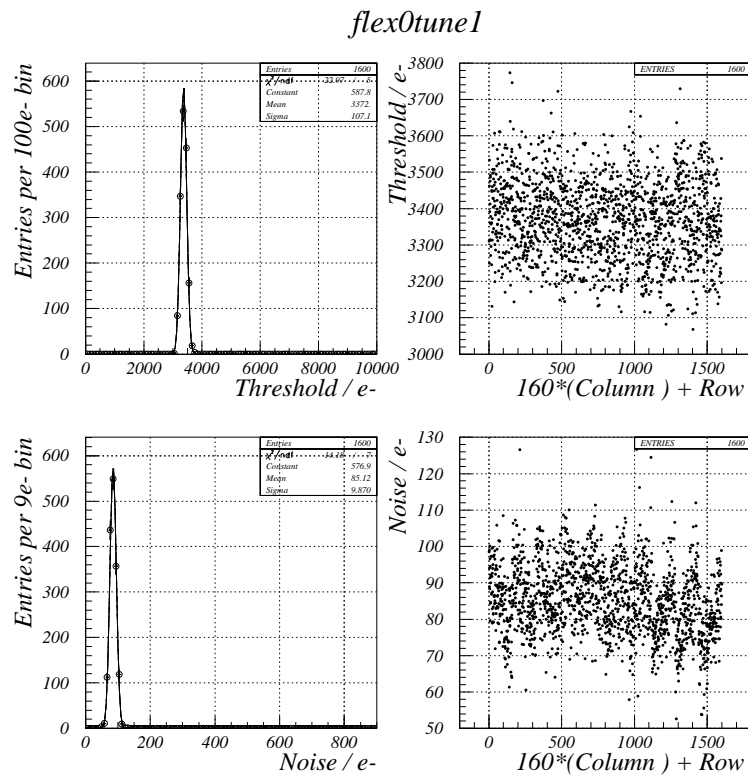
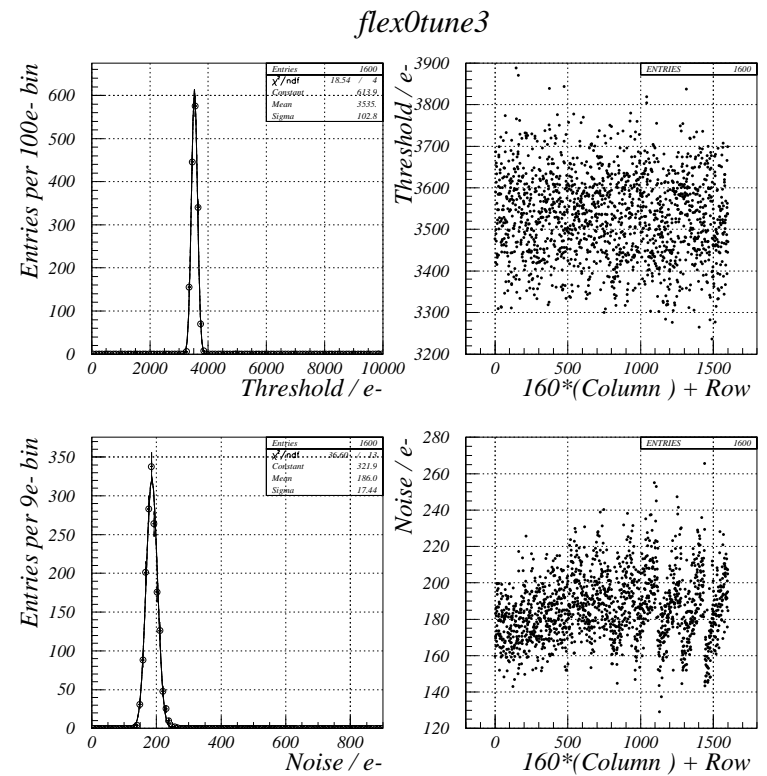
- This flex and MCC worked OK, but some of the chips were noisier than expected. An example of one chip scanned twice:

- One lesson from this: in the single chip cards, the chips were always attached with conducting epoxy, whereas in the modules, we used Dow340 plus UV-cure epoxy (insulating). For the Flex, we used conducting epoxy, and it still shows qualitatively similar noise effects to the full module. Probably the substrate contact method is not the problem...
